Manhole Inspection Summary

Manhole # S51K__004MH

Insp Date: **9/14/09 9:04 AM**

Location Address: **3011 Fait Ave.**

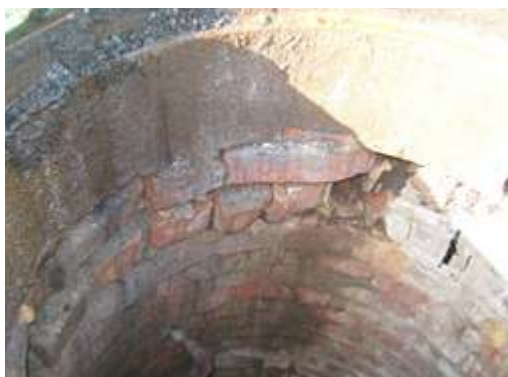
Defect 6

Condition: ☐ Sound ☒ **Cracked** ☐ Root Intrusion ☒ **Loose Brick** ☒ **Deteriorated**

Infiltration: ☐ None ☒ **Joint** ☐ Cracks ☐ Mortar ☐ Roots ☐ Wall

chimney deteriorated with cracked & loose brick & infiltration from joint

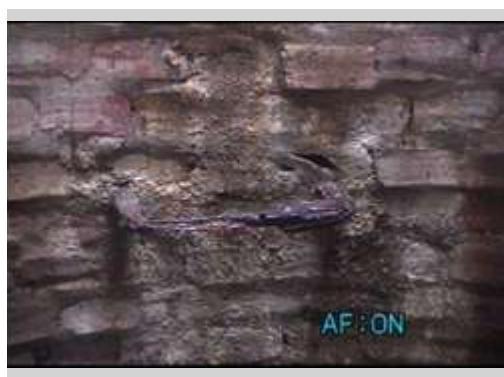
Defect 1

Infiltration: ☐ None ☐ Joint ☐ Cracks ☒ **Mortar** ☐ Roots ☒ **Wall**

Count: **5** Missing: **0** ☒ **Corroded**

corroded rung with signs of corbel infiltration from mortar/wall

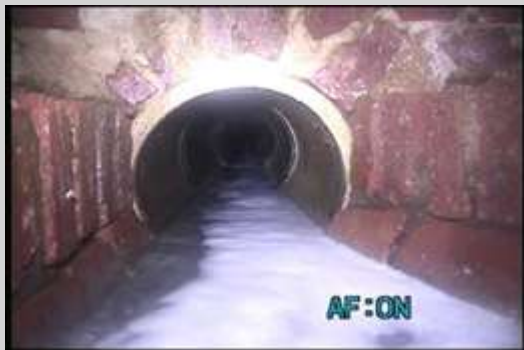
12 O'Clock Outflow

Pipe Height: **8.4** (in.) Rod and Bar (Angled)
Pipe Material: **Clay** ☐ Pipe Lined
Invert Depth: **10.26** (ft.) Flow Characteristics: **Slow**
Deposits: ☒ None ☐ Mud ☐ Sludge ☐ Debris ☐ Grease
Silt Depth: **0** (in.) Deposits Extent:
Infiltration: **None** Pipe Seal Cond: **Sound**

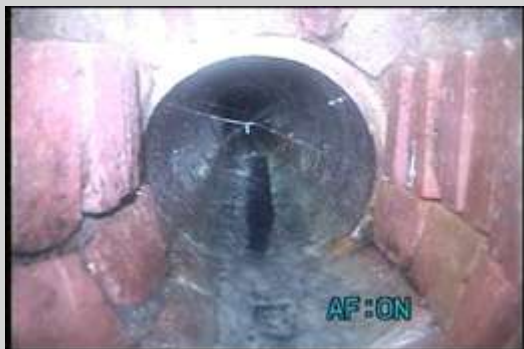
3 O'Clock Inflow

Pipe Height: **8.4** (in.) Rod and Bar (Angled)
Pipe Material: **Clay** ☐ Pipe Lined
Invert Depth: **10.18** (ft.) Flow Characteristics: **None**
Deposits: ☒ None ☐ Mud ☐ Sludge ☐ Debris ☐ Grease
Silt Depth: **0** (in.) Deposits Extent:
Infiltration: **None** Pipe Seal Cond: **Sound**

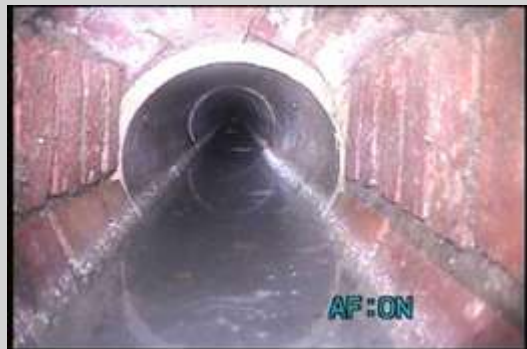
6 O'Clock Inflow

Pipe Height: **8.4** (in.) Rod and Bar (Angled)

Infiltration: **None** Pipe Seal Cond: **Sound**
